Manhole Inspection Summary

Manhole # S17EE2040MH

Insp Date: **8/9/06 12:00 AM**

Location Address: **1816 SULGRAVE AVE**

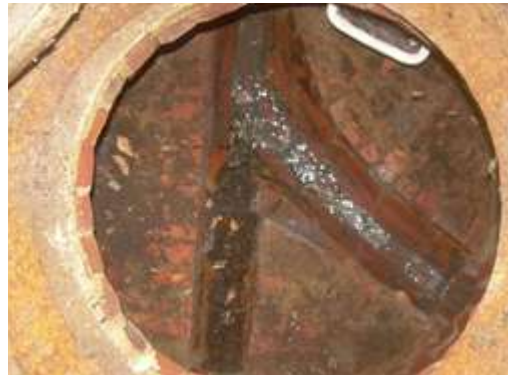
Top View

Evidence of surcharge - Bench debris.
Channel debris.

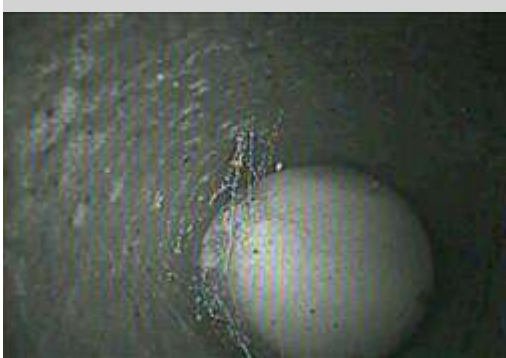
Inside the I6

Plugged.

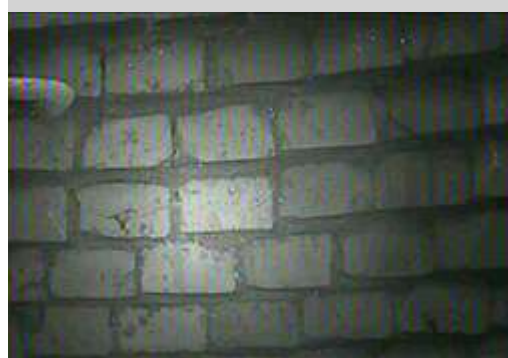
Defect

Infiltration: ☐ None ☐ Joint ☐ Cracks ☒ **Mortar** ☐ Roots ☒ **Wall**

Barrel infiltration.

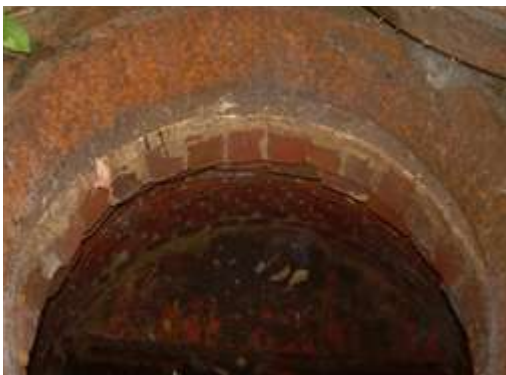
Defect

Frame Offset: **1.5** (in.) Condition: ☒ Sound ☐ Cracked ☐ Leaks

Infiltration: ☐ None ☒ **Joint** ☐ Cracks ☐ Mortar ☐ Roots ☐ Wall

Frame offset. Adjustment and Barrel infiltration.

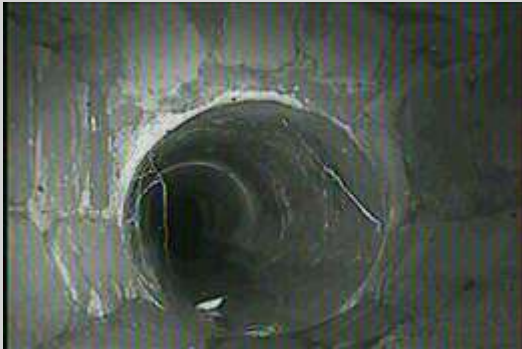
8 in. Circular Gravity Sewer Pipe Out @ 12 O'Clock

Infiltration: **Evidence** Pipe Seal Cond: **Unknown**

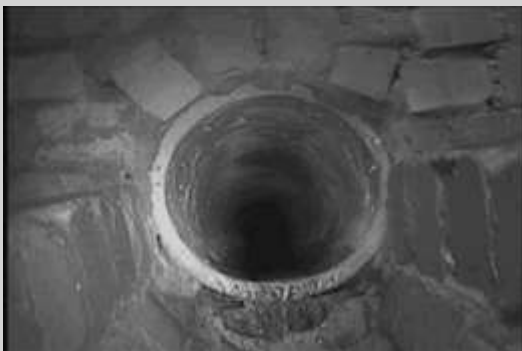
8 in. Circular Gravity Sewer Pipe In @ 4 O'Clock

Infiltration: **Evidence** Pipe Seal Cond: **Unknown**

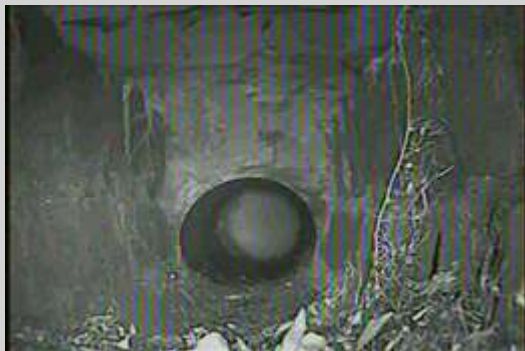
Pipe In @ 6 O'Clock

Connects To: **Stub connection / abandoned**
☐ Possible Illicit Connection
